## **ARCHAEOLOGICAL INVESTIGATION REPORT:**

**North East Bastion, King's Lynn**

David Flintham,  
Project Director, King's Lynn under Siege  
May 2025

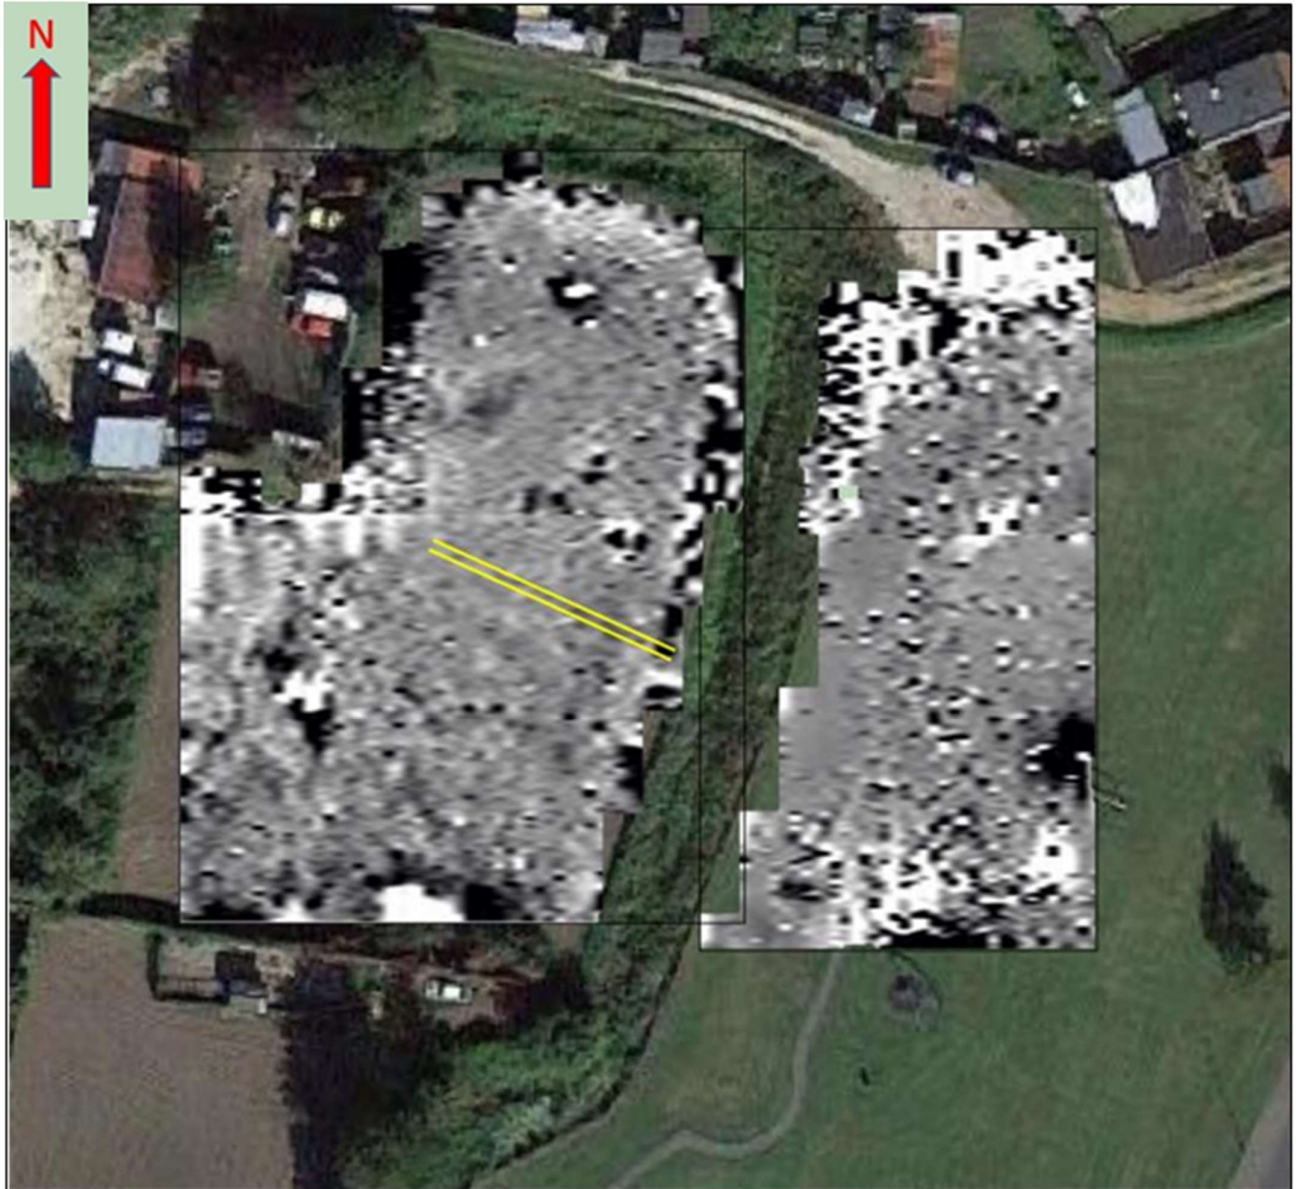
*Figure 14 - Results of the March 2022 Magnetometry on Qgis  
This survey informed the project's investigations between 2022 and 2024. The location of the 2021 Trench marked in yellow*

- 5.1. The project is not aware of any previous magnetometry (nor resistivity / GPR) having been undertaken on this site prior to 2022.
- 5.2. The Fluxgate Gradiometer Survey took place on 24<sup>th</sup> and 25<sup>th</sup> March 2022 (see ENF151503<sup>9</sup>).
- 5.3. The survey made the following recommendations:
  - 5.3.1. It may be worthwhile re-visiting the location and positioning of the various maps of the defensive structure based on the accurate location of the magnetometry picture now available.
  - 5.3.2. Invasive excavation should follow. The accurate positioning of the grids in this report should assist the location of the trench / trenches proposed

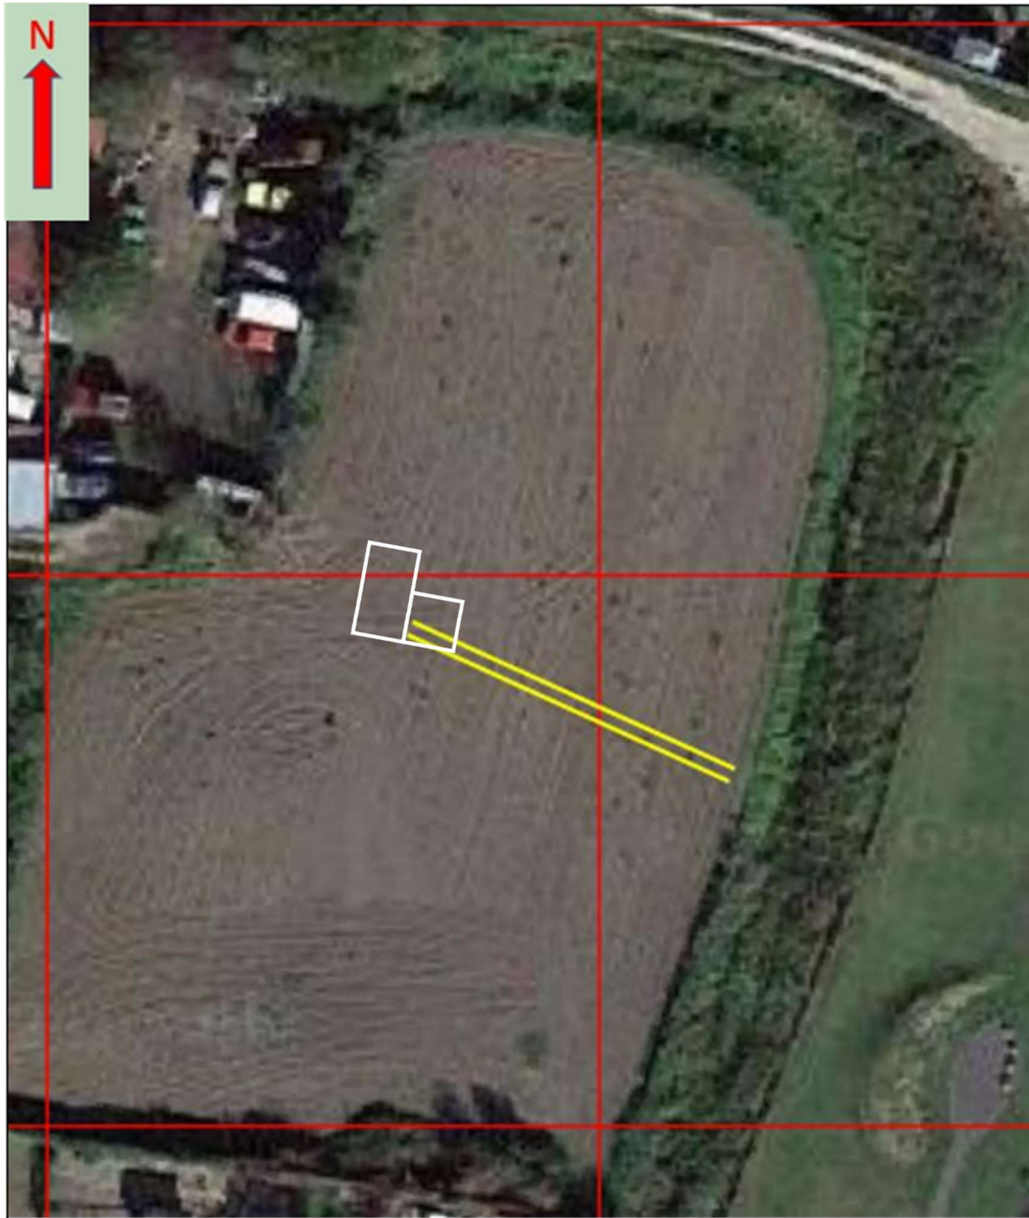
*Figure 16 – Revised 2022 Trench location*  
(shown alongside the site of the 2021 trench in yellow)

7.4. However, due to the unprecedented hot weather conditions, it was decided to open a single trench (Trench A), but would make this bigger than the original plan.

7.5. As a result, Trench A became 'L'-shaped, occupying an area of 6.9m (N-S) x 7.52m (E-W).

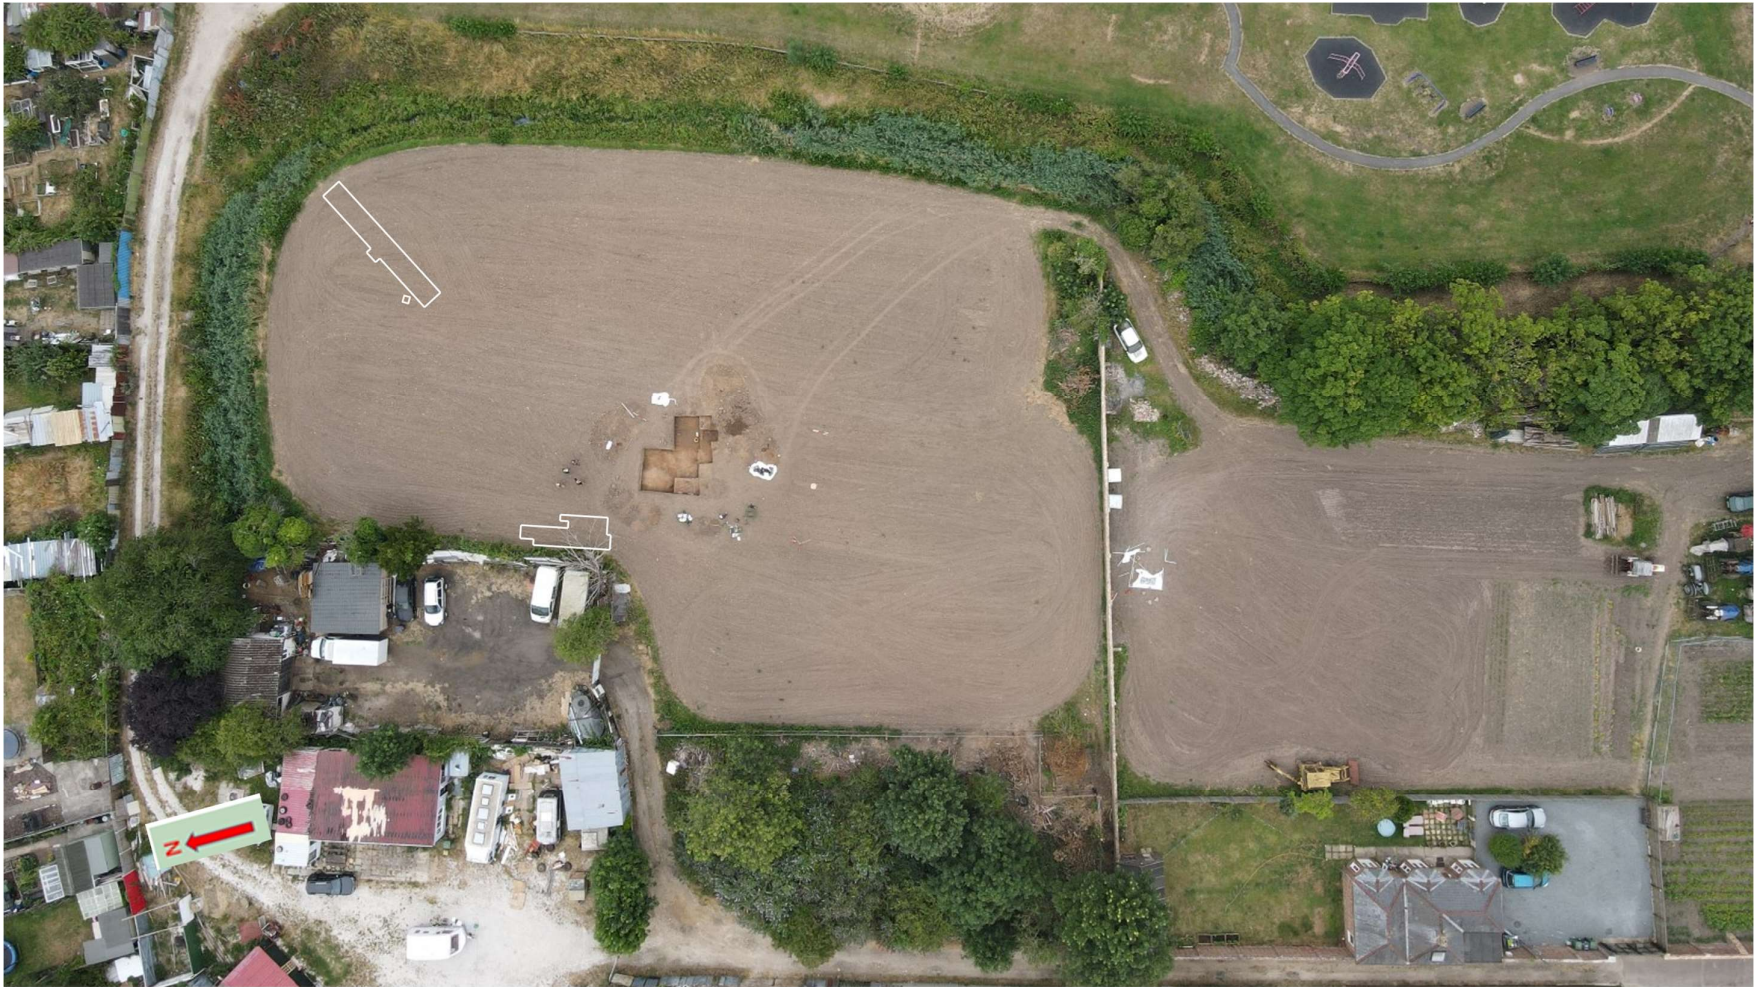
Figure 19 – 2022 aerial view showing the approximate locations of the 2024 trenches  
(In white): Trench A (lower-centre) and Trench B (upper-left)

- 13.1. The July 2024 investigation is referenced as follows:
  - ENF155898 – Two trenches (Trench A and Trench B).
- 13.2. Trench A would measure 7m by 3m and would be located as close as possible to the western edge of the site.
- 13.3. Trench B would be the main trench and would measure 15m long by 1.9m wide. It would be located in the angle of the bastion itself.
- 13.4. The opening of both trenches would be by a mini digger ahead of the actual dig itself.
- 13.5. Subsequent excavations would be hand-dug.
- 13.6. During the dig, Trench A was extended and would ultimately occupy an overall area of 8.64m by 3.84m

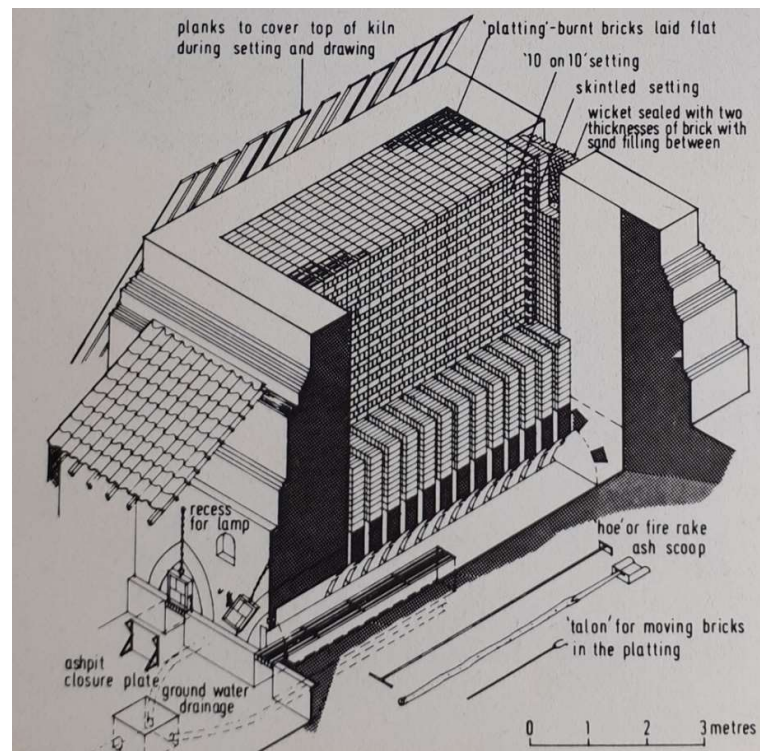
Figure 23 – A drawing of a Suffolk brick kiln

tunnels below the floor of the kiln, the bricks were set on the level floor of the open-topped firing chamber, the top of which was then sealed with old bricks. Flames would reach the chamber through slots in the fire tunnel arches. The wood for fuel went straight into the tunnels. Working in shifts, two burners would remain at the kiln for the whole three-day firing period<sup>35</sup>.

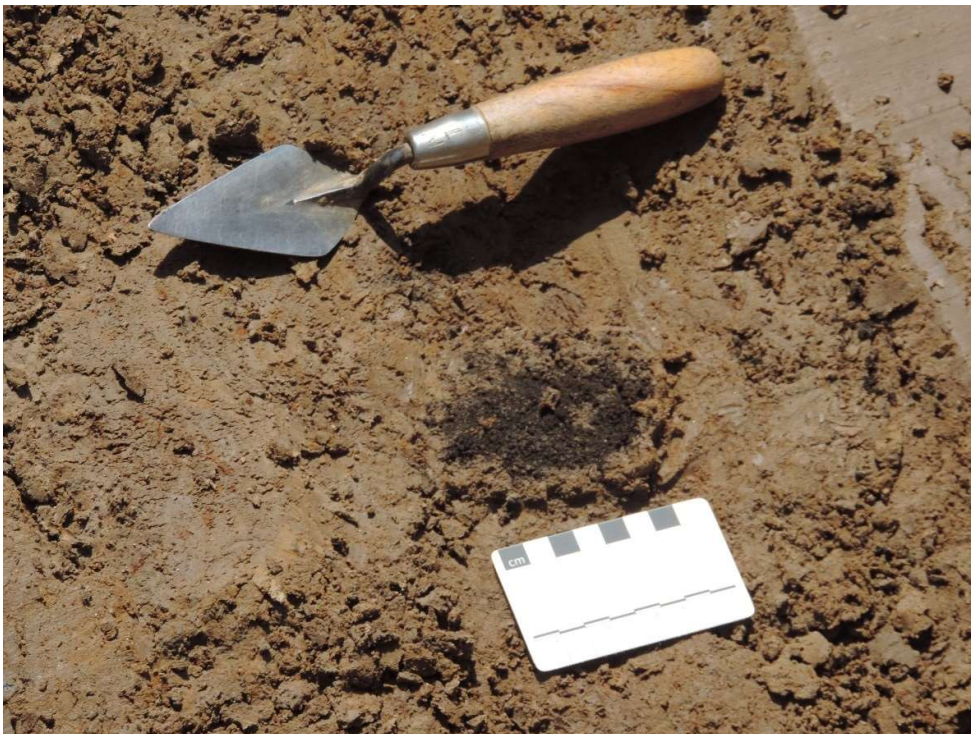
*Figure 28 - Close up of 2022 trench post as revealed (Image number: 0310)*

- 8.1.6. Miscellaneous/unidentified/undated
- 8.2. It was noted that the post discovered during the 2021 dig was not adequately protected when the trench was backfilled at the end of the investigation. As a result, some deterioration of the post had occurred. Both this post and the post discovered in July 2022 were protected when the trench was backfilled.

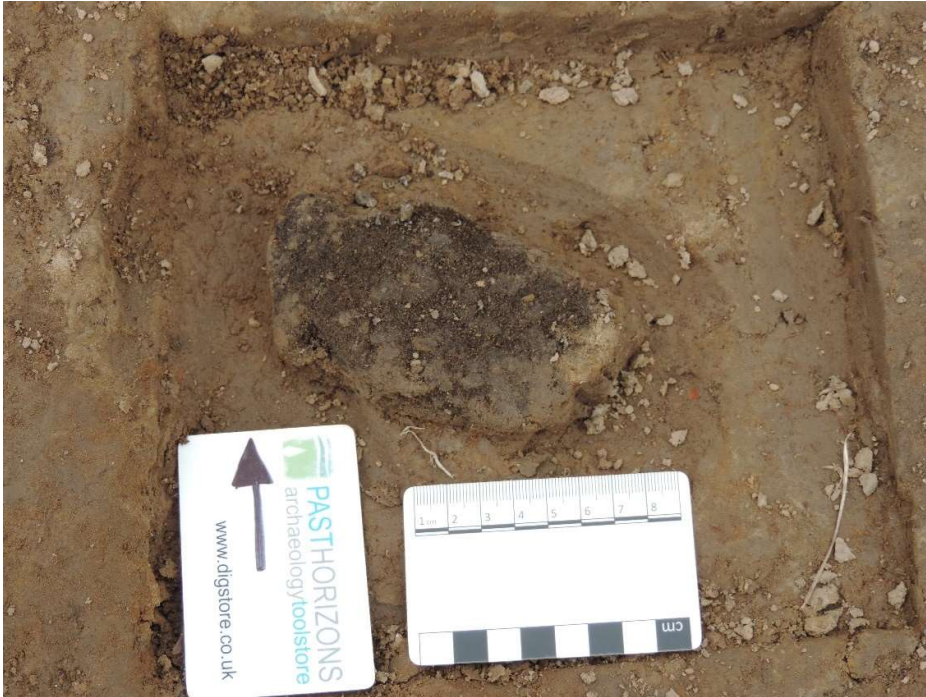
Figure 29 - Close up of 2022 trench post - cleaned (Image number: 0359)

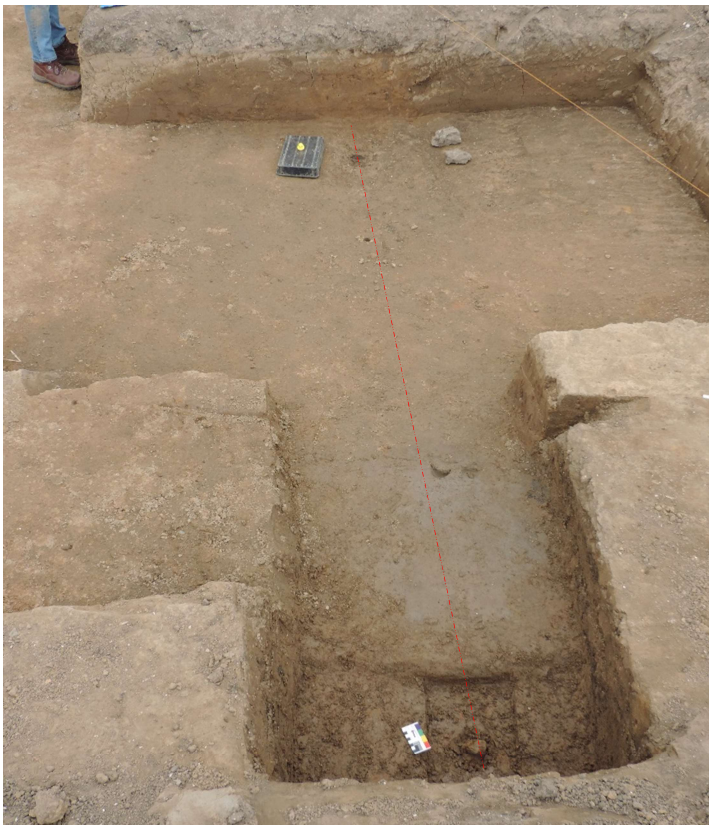
Figure 30 - View of trench posts in alignment (Image number: 0349)  
The dotted line indicates the alignment of the two posts

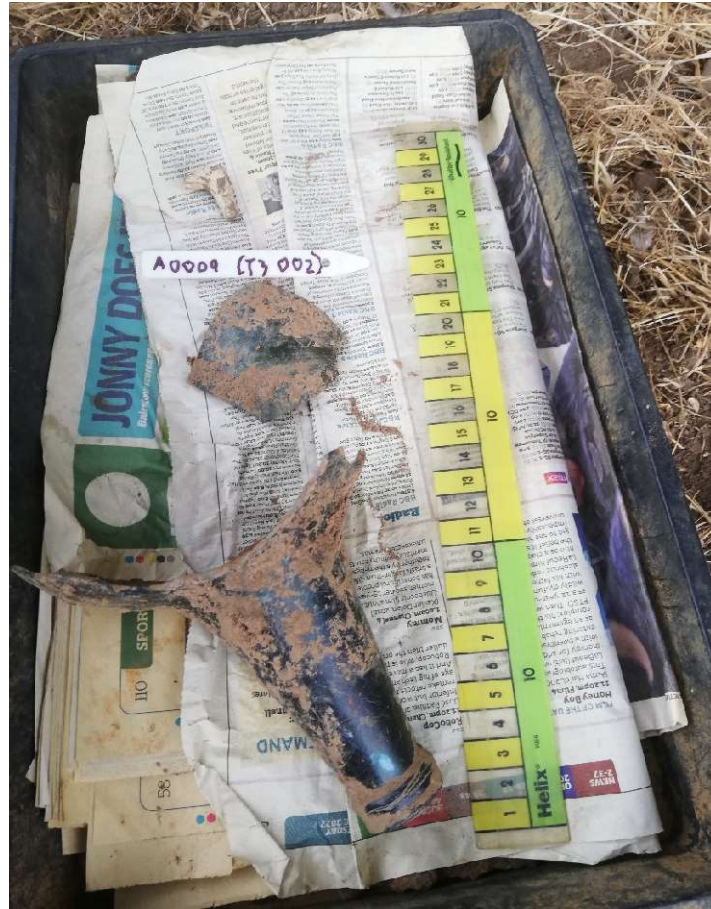
Figure 31 - Late 17th century 'Onion' bottle as discovered (Image number: 2821)  
The discovery of two pieces of a late 17<sup>th</sup> century onion bottle was the star find of the 2022 dig

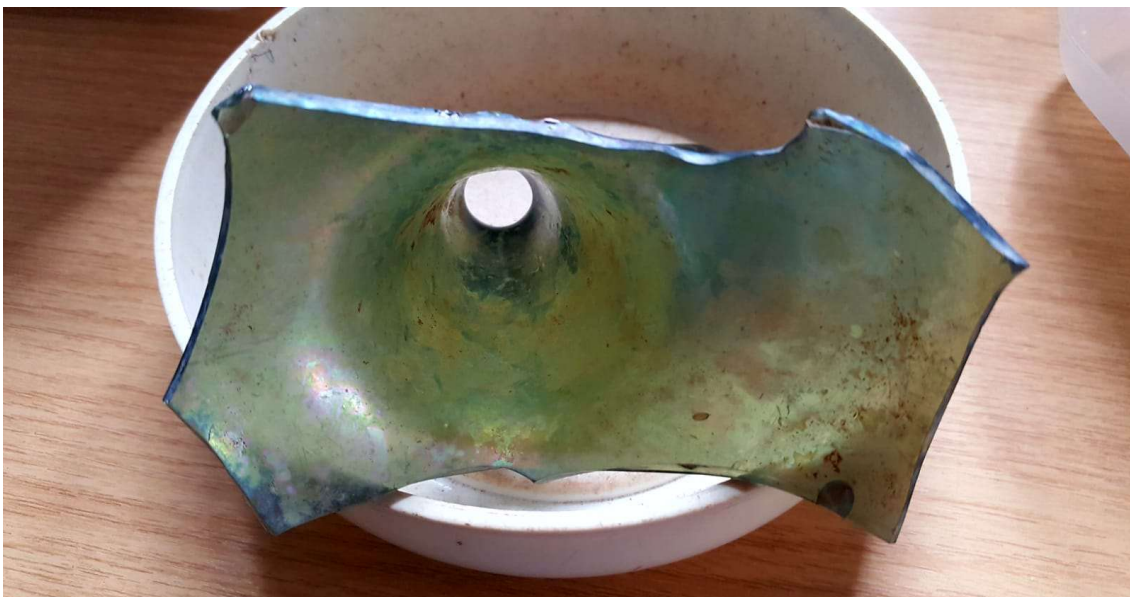
Figure 32 - Late 17th century 'Onion' bottle after cleaning (Find number: F009-39)  
This is a picture of the neck of the onion bottle following cleaning and processing by SHARP

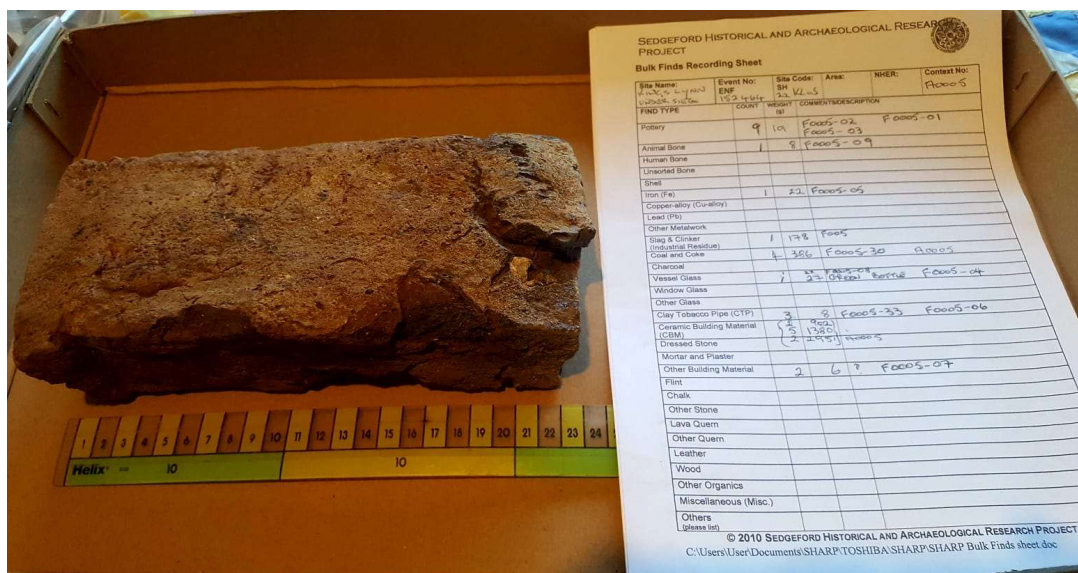
Figure 33 – Mis-shaped brick (Find number: F005-12)

This mis-shaped brick is an example of debris from the brick-making process

- 8.8. The site's later role in brickmaking is demonstrated by a number of finds including bricks and mis-fired bricks, other pieces of ceramic building material, pieces of charcoal, and other pieces of burnt material. Higher concentrations of bricks, etc. were encountered at the western edge of the trench suggesting that this was the edge of the brick kiln area.

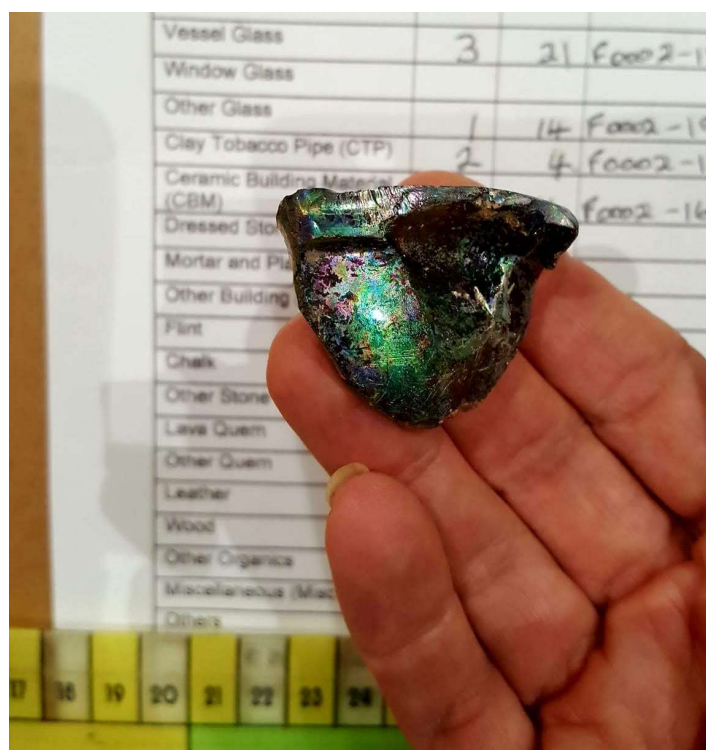
Figure 36 - Mis-shaped glass (2022)

A piece of Mis-shaped glass found in the northern part of the July 2022 trench. The photograph was taken following cleaning and processing by SHARP.

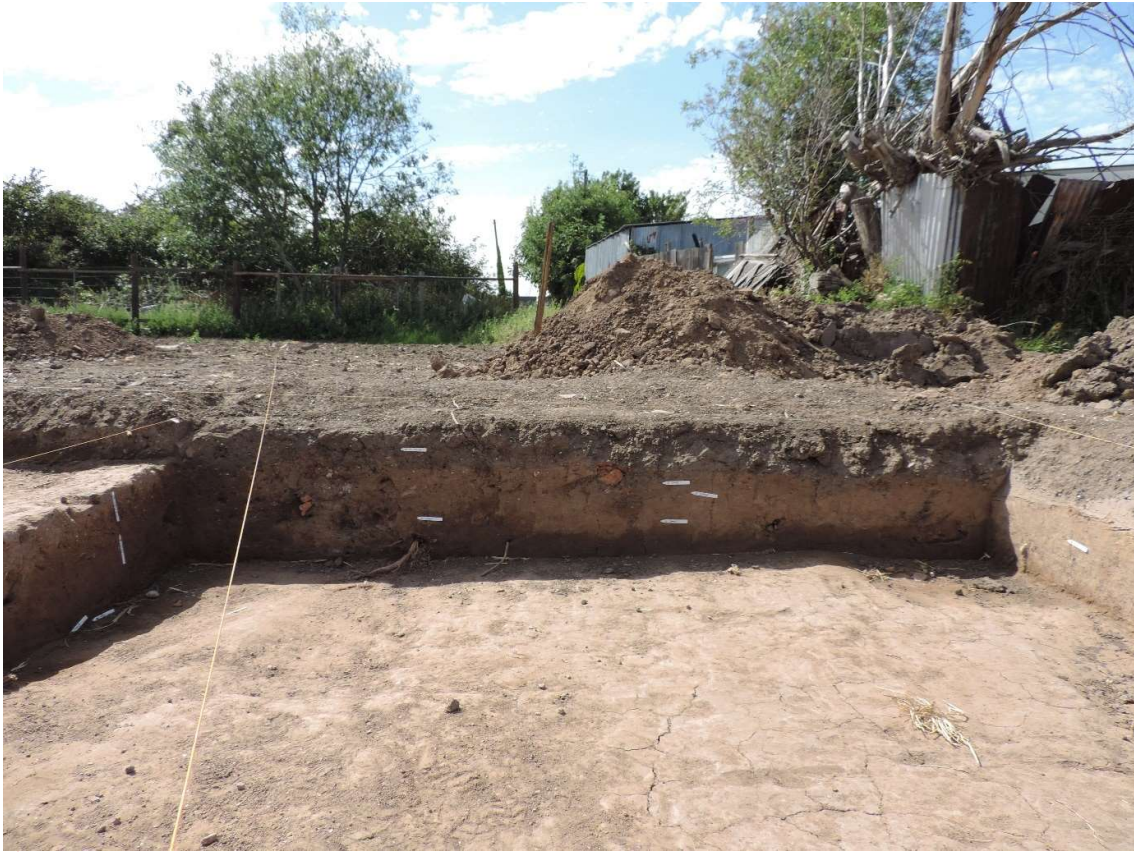
*Figure 37 - View of the western side of trench A (image number: 0352)*  
Trench wall (A001) looking west. Parts of A002 (right) and A005 (left) are also shown

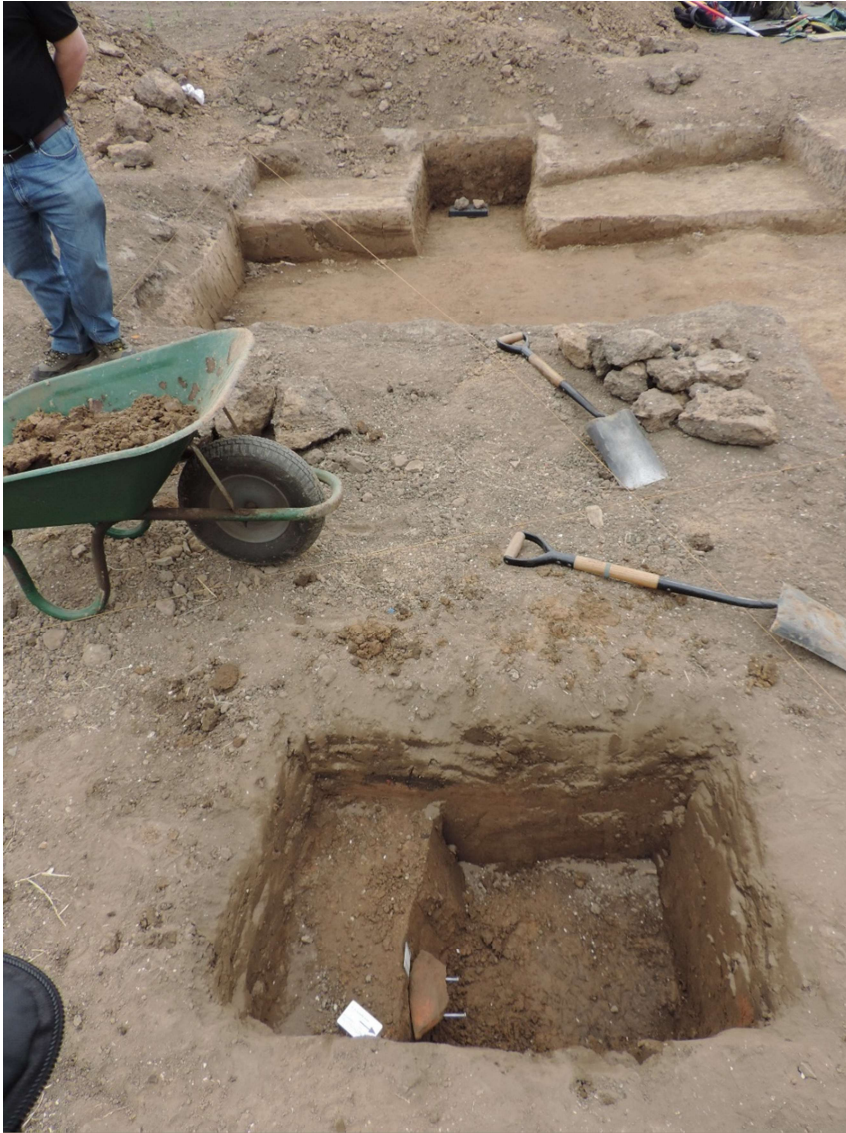
*Figure 38 - Test pit 1 (image number: 0364)*

View of Test Pit 1 looking south. A large piece of clay tile is in the process of being excavated. In the background is A004, and also A006 which contains (beneath the up-turned finds tray) the rampart post originally discovered in 2021

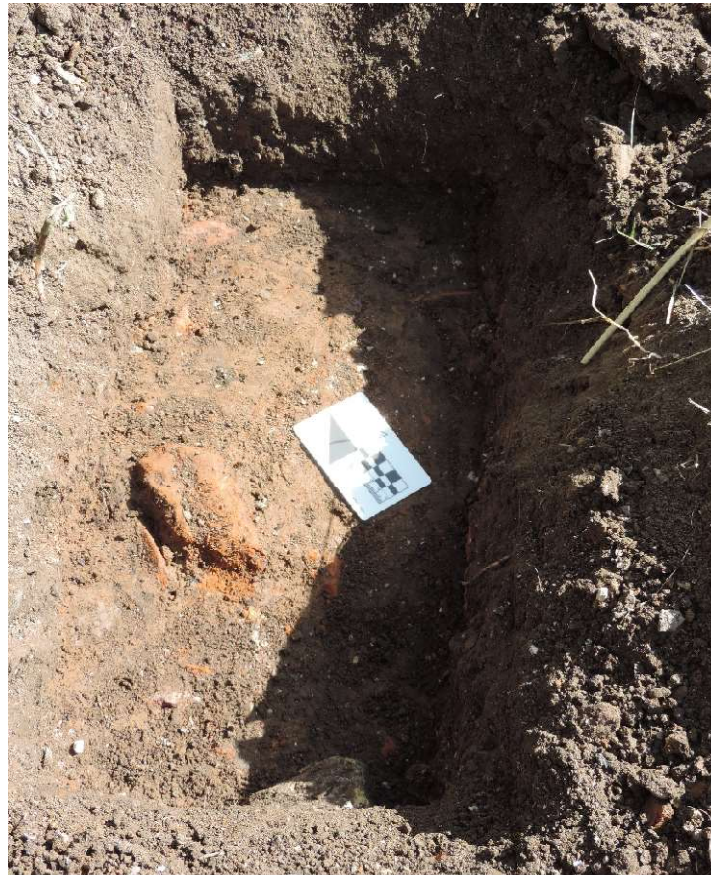
*Figure 43 - View of test pit (image number: DSCN0728)  
A test pit was excavated at the western edge of the site, close to the likely site of the brick-kiln. Brick pieces were found in the layer beneath the topsoil*

- 11.4. Two test pits at the western edge of the site confirmed the presence of bricks, including misfired bricks.
- 11.5. Further fieldwalking the site observed a variety of material including pieces of cockle and oyster shells, and pieces of ceramic including brick.

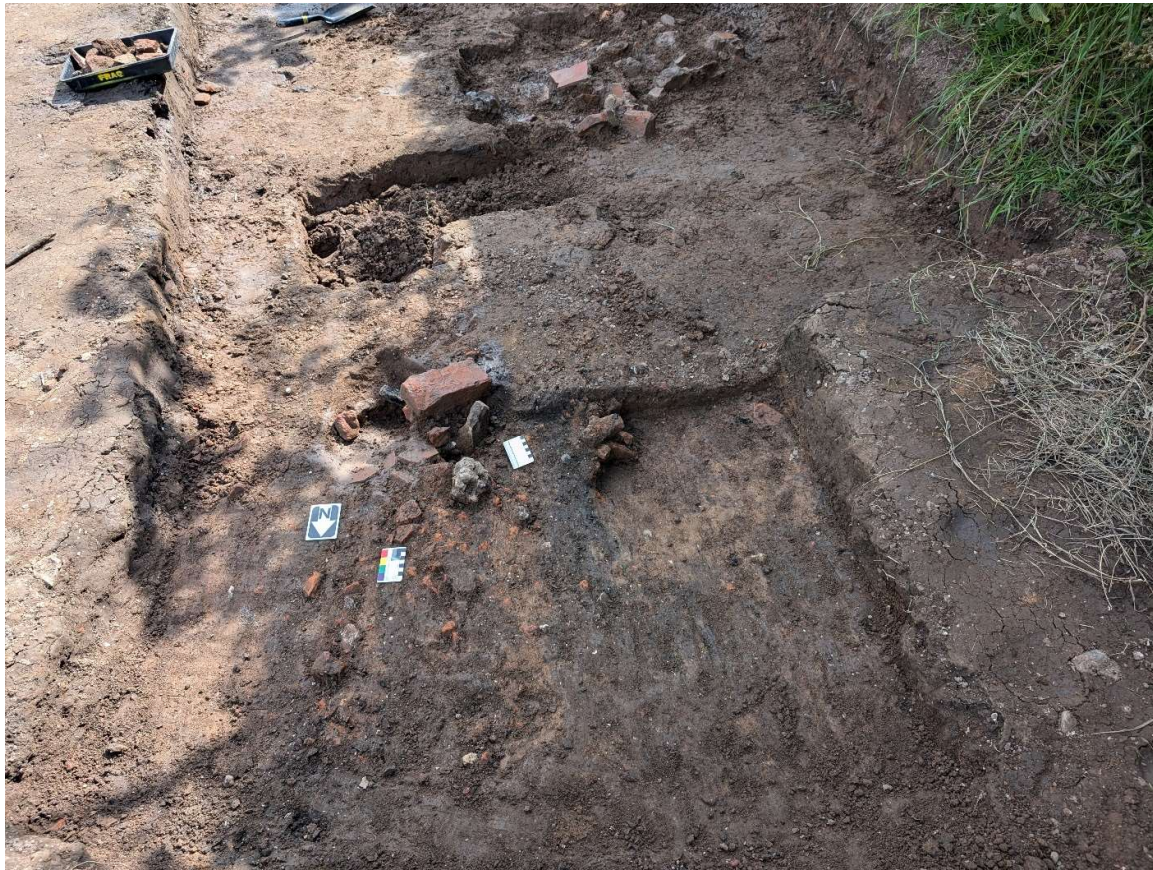
*Figure 49 – Overview of Trench A (image number: 6440)*  
Overview of the northern part of Trench A, looking south

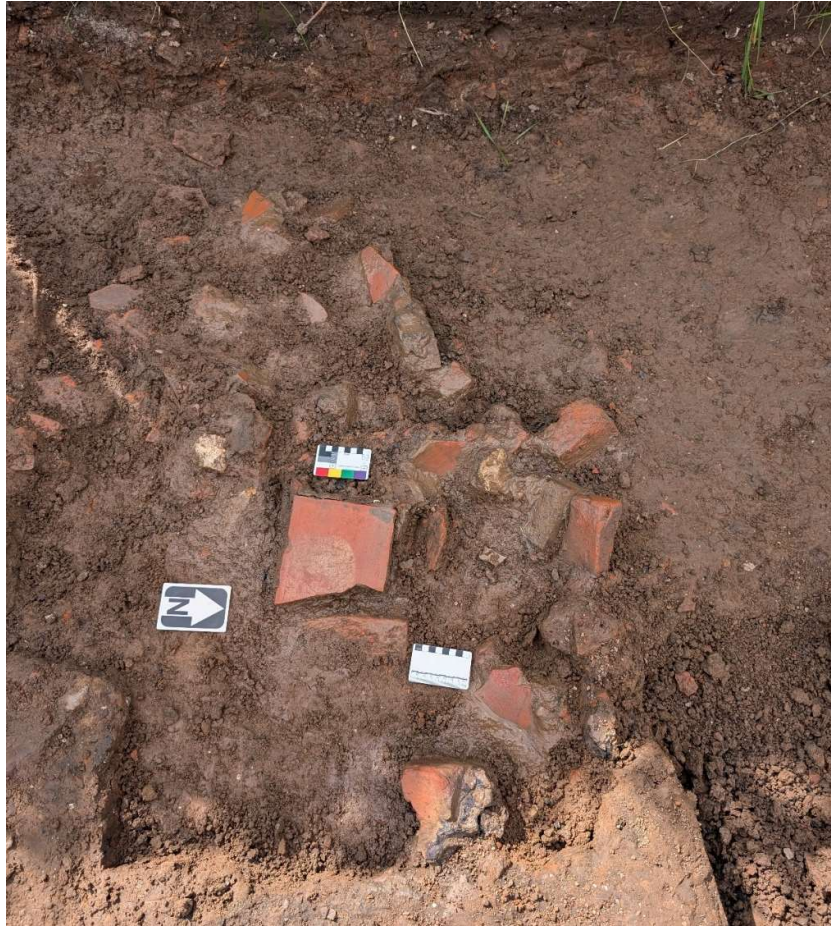
*Figure 50 - View of gathering of bricks and tiles in trench A (image number: 5394)*  
 A view of the central part of Trench A (looking west) showing the gathering of bricks and tiles. Note the absence of mortar.

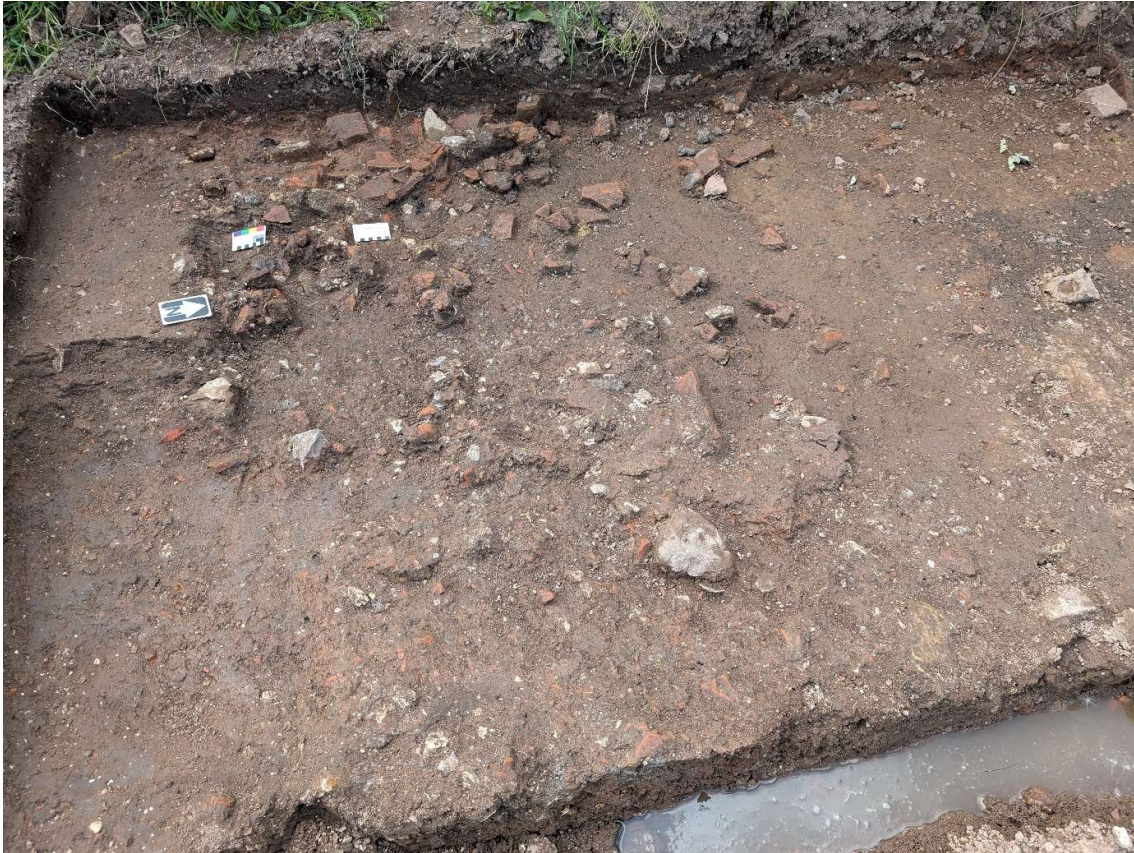
*Figure 51 - Overview of trench A (image number: 6862)*  
Trench A (southern part, viewed looking west) showing gathering of brocks and tiles

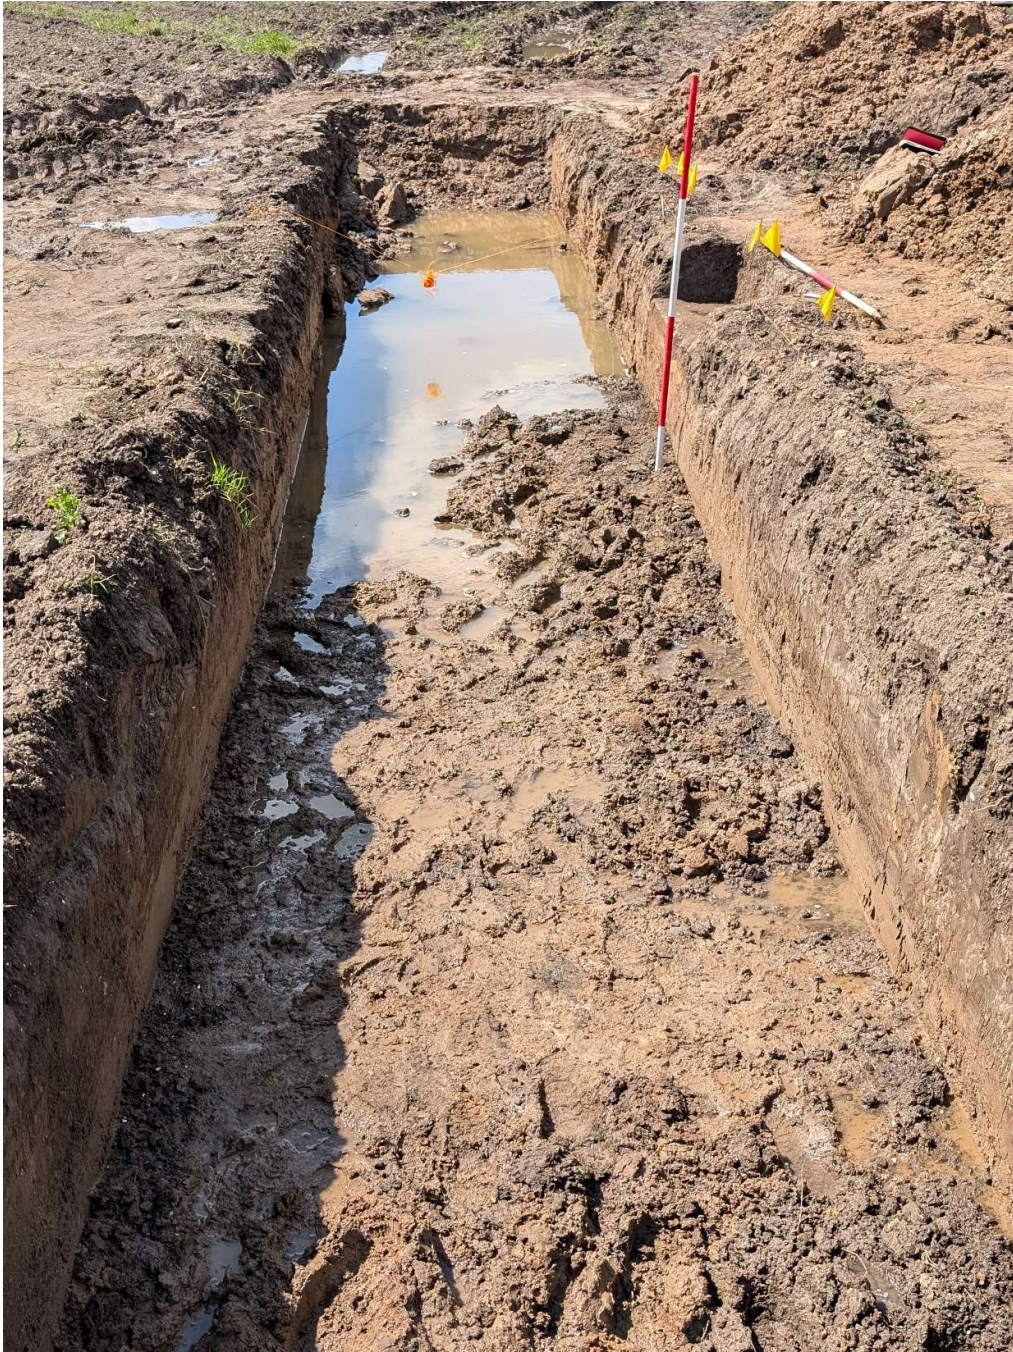
*Figure 52 - View of trench B looking south-westwards (image number: 7913)*  
Overview of Trench B, looking south-west. Insert to right

Peter and Iain finished excavating the insert in Trench B to chase the suspected ECW cut. This was on the northwestern side of the trench and was 6.8m from the northeastern end of the trench (e.g. closest to the existing ditch). The insert measured 1.4m x 0.4 to 0.5m, and was 0.3m below the surface (and 0.54m from the bottom of the trench). There were no further signs of the ECW cut, so it was decided to cease further work on the trench. It was recorded and then the trench was closed down. As has been the case throughout the dig, work was focused on Trench A. Nick (P) and Chris focused on the southern end of the upper section, extending it further south. Jo, then joined by Peter and Iain, focused on cleaning the central section, and Alex and Charlie focused on the northern part of the upper level, extending it further north.

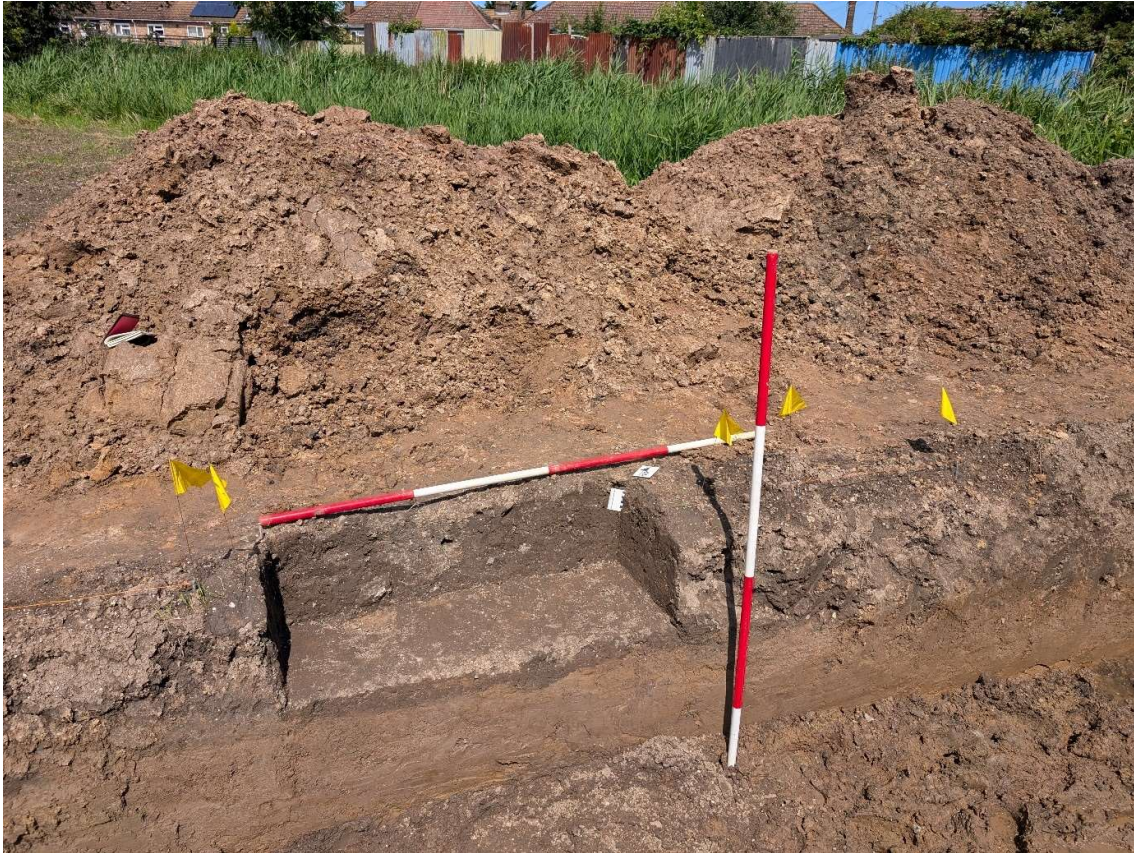
*Figure 53 - View of possible Fausse-Braye cut (image number: 9244)*  
Trench B insert looking north-west, showing contexts 001-004

- 14.1. Due to weather conditions, excavations around Trench B were severely restricted. However, a cut in this trench possibly matched with the *Fausse-Braye* feature (*Context 003*). Unfortunately, conditions prevented a full examination of this feature.

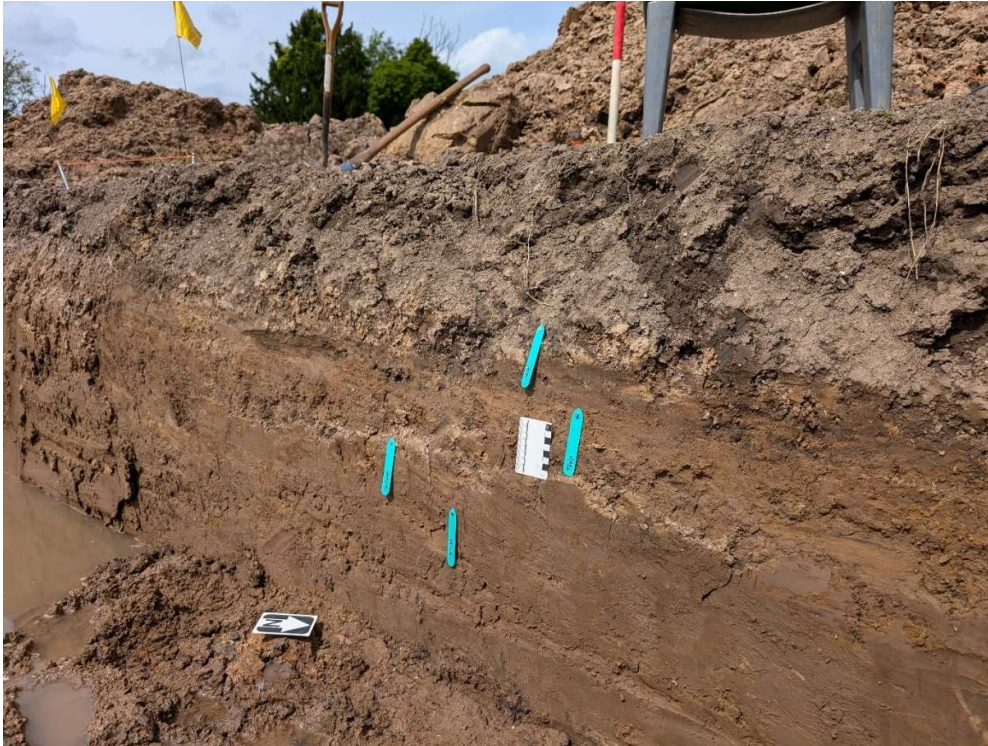
*Figure 54 – NW-side of trench B (image number: 9805)*  
 Northwest side of Trench B showing 4 contexts (possible ECW cut, possible top of Fausse Braye). See also Figure 48

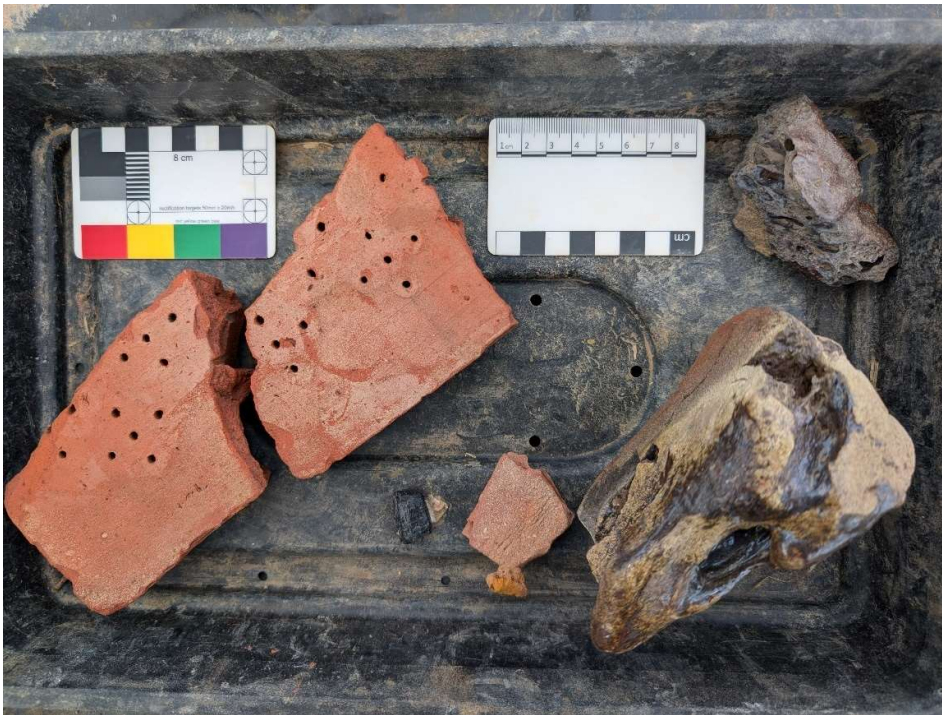
*Figure 56 - Trench A finds tray (image number 3660)*

A view of a finds tray from Trench A. Of particular note is the piece of brick on the right that has been exposed to very temperatures (higher than those required to fire bricks)

- 14.5. Some bricks were found to have glazing on faces [Find: 002] which was the result of the silica content melting and then solidifying once cooled. As the silica crystal structure starts to break down at about 575 degrees Celsius, construction bricks cannot be fired at any higher temperature. It is unlikely that this caused by firing in the brick kiln. As far higher temperatures are used in iron working, this, together with other finds [Finds: 005, 034, 036, 039] suggest that iron working took place on the site. There is no documentary evidence to support this, but it is possible that such activity did take place during the construction of the fortifications, for instance, allowing tools to be repaired on site.

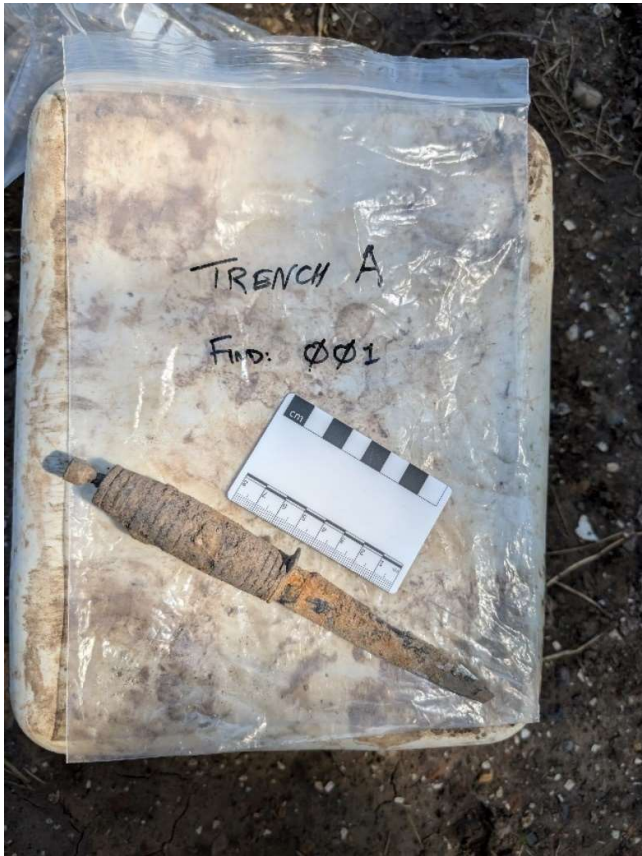
Figure 59 - Find 001 (image number: 3540)  
A German-made knife probably dating from the 1950s

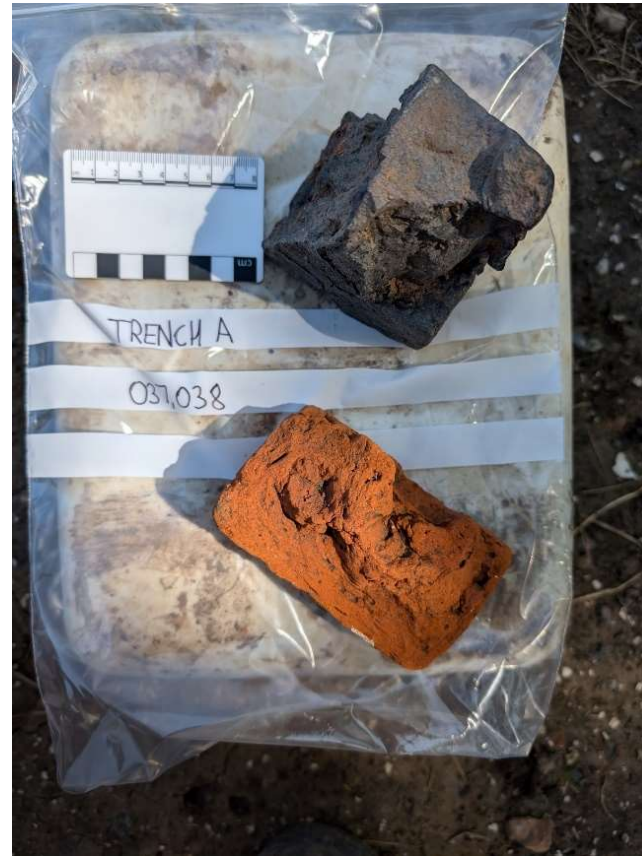
Figure 60 - Finds 037, 038 (image number: 3625)  
Two pieces of brick from Trench A. The grey piece (find: 038) is a piece of brick that has blown on firing, caused by incomplete drying prior to firing.

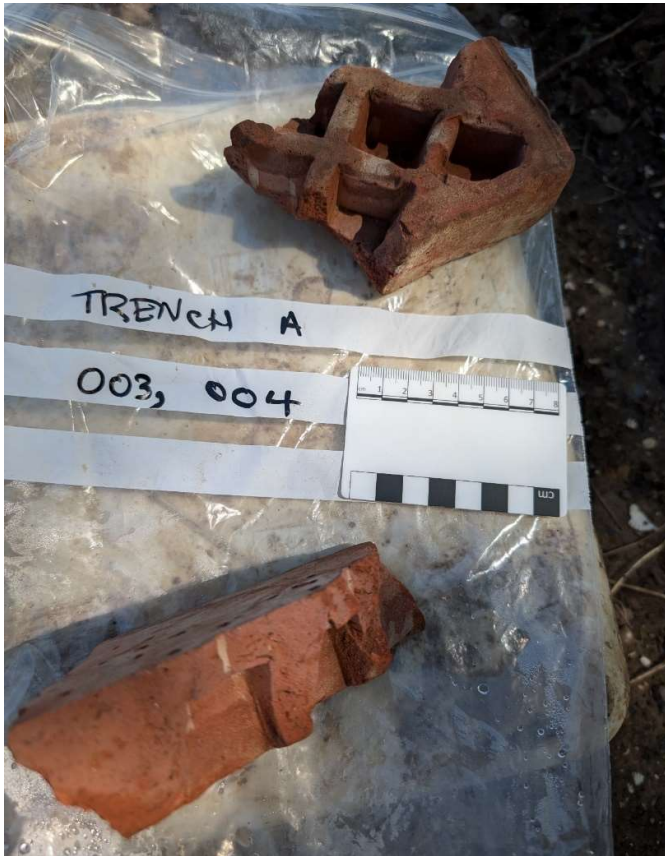
Figure 61 - Finds 003, 004 (image number: 6614)  
Two pieces of sagger bricks. These might have been produced for hop kilns for local brewers

- 14.4. In addition to the manufacture of bricks for construction purposes, 'honeycomb' bricks were also found [Finds: 003, 004, 021, 022]. This type of brick was used in the construction of kilns to dry hops, a key component in the brewing of beer. This provides a link between the site and the town's brewing industry<sup>13</sup>.
