## **ARCHAEOLOGICAL INVESTIGATION REPORT:**

**North East Bastion, King's Lynn**

David Flintham,  
Project Director, King's Lynn under Siege  
May 2025

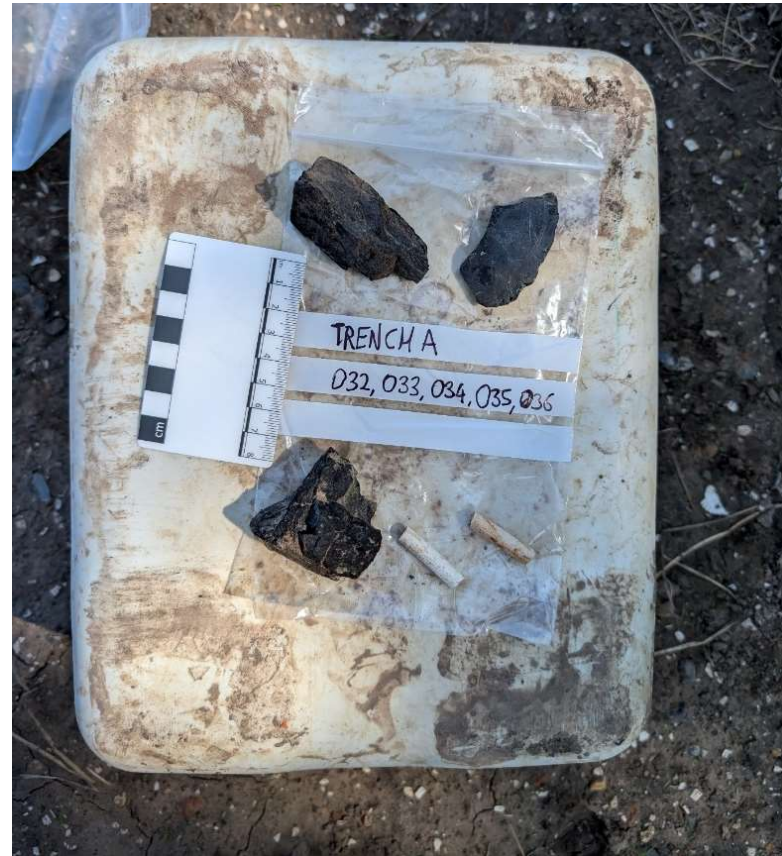
Figure 62 - Finds 032, 033, 034, 035, 036 (image number: 3351)  
A selection of finds from Trench A, including two pieces of clay pipe stems (Finds: 032, 033)

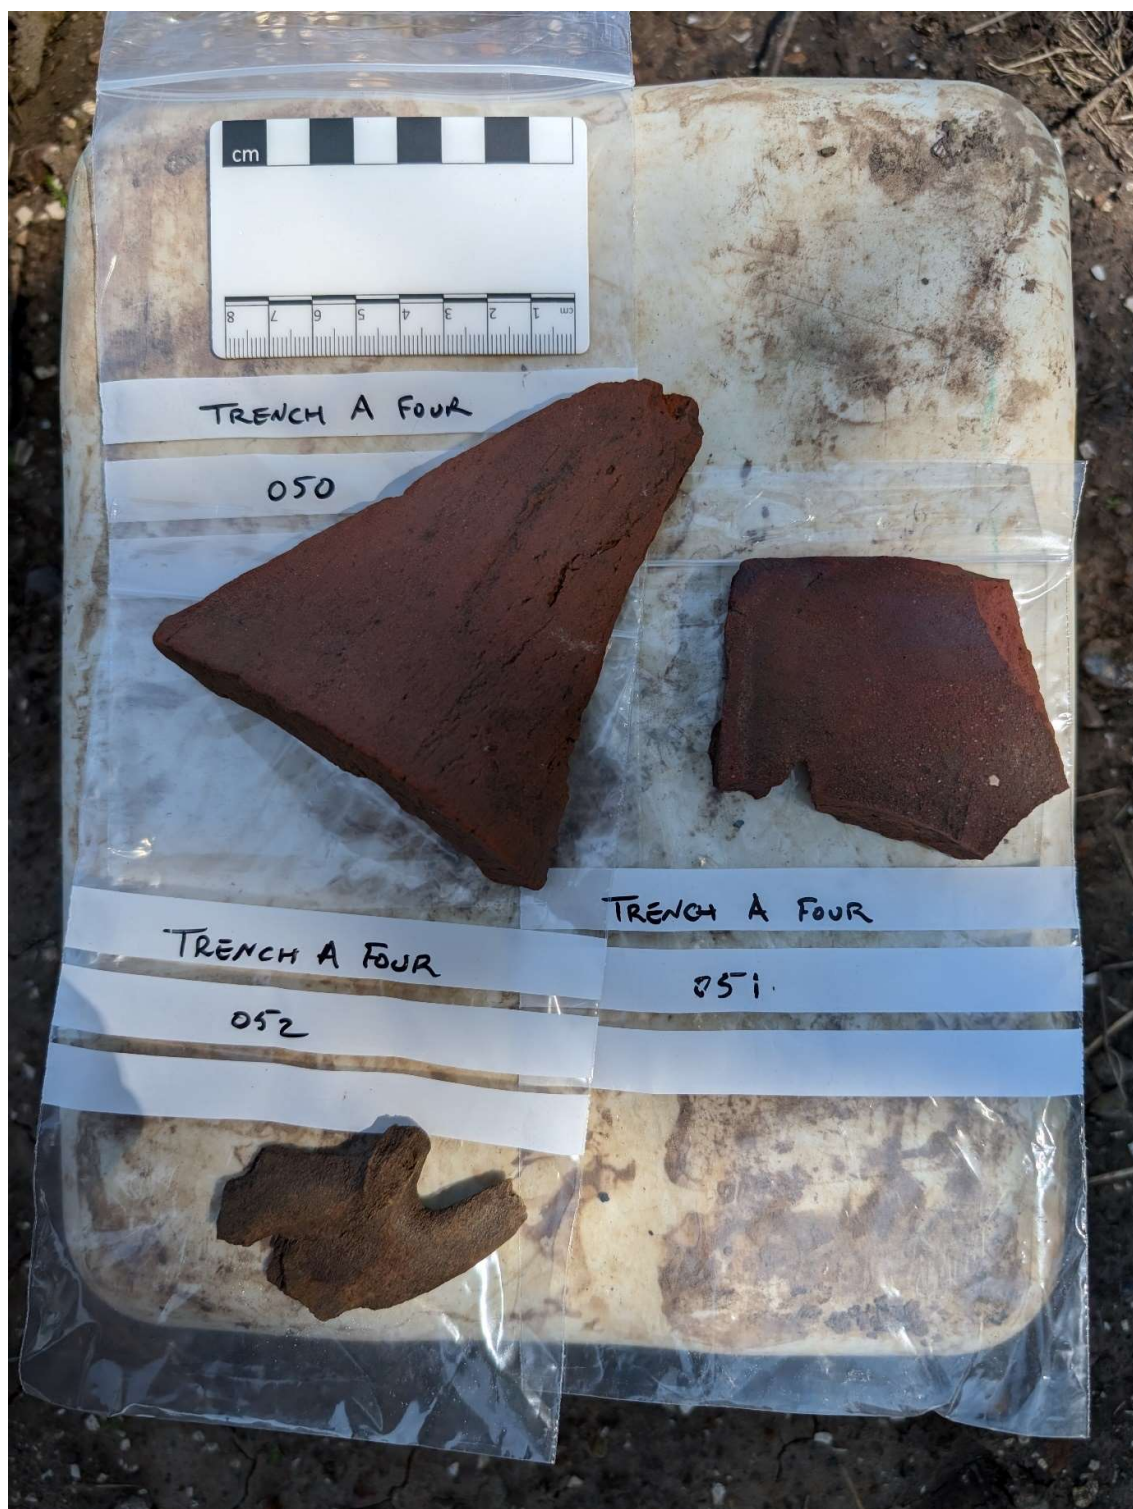
Figure 63 - Finds 050, 051, 052 (image number: 2711)

Two pieces of roof tile (note nail hole in 051) and a piece of bone (052) from Trench A

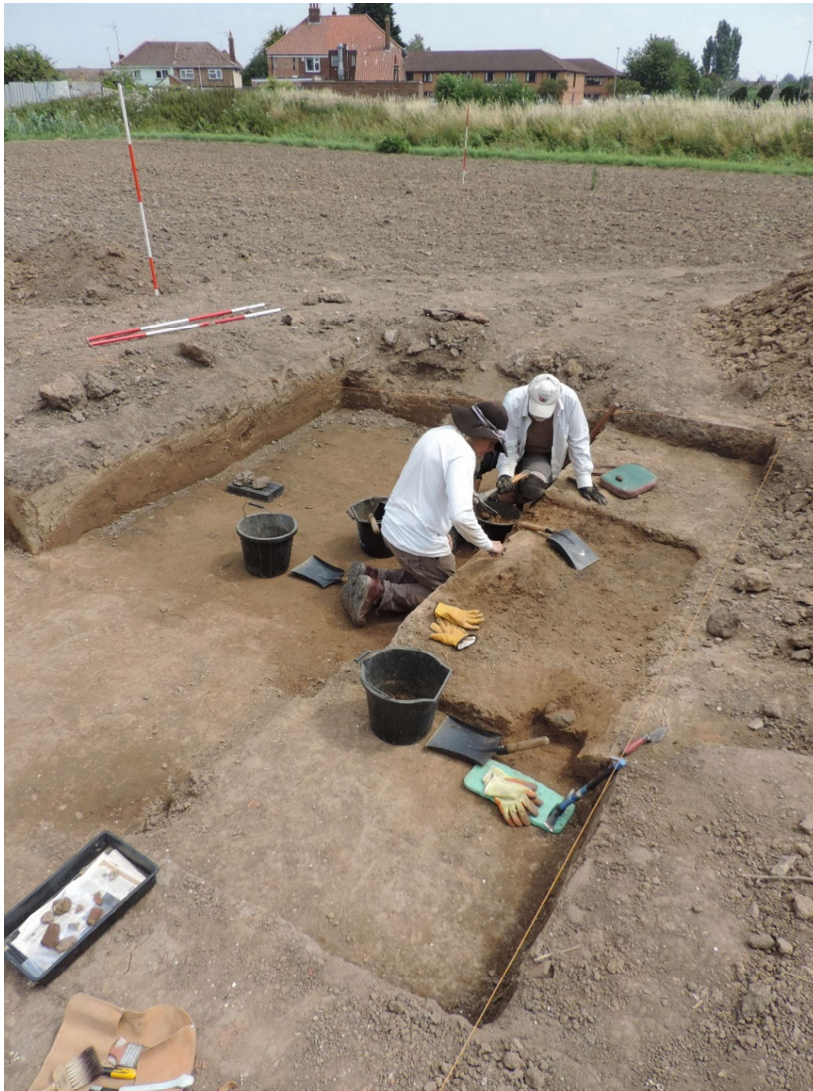
*Figure 65 - Work in progress (2022 - week 1) (Image number: 0318)*

Work is underway during week 1. The first rampart post has already been discovered (and is protected beneath an upturned finds tray)

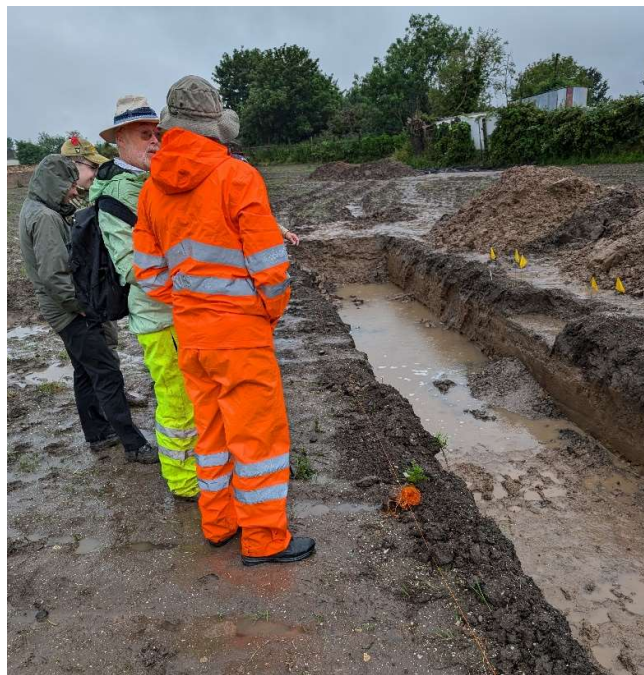
*Figure 72 - Rain day (image number: 022)*

Arrived to find that following the heavy overnight rain, the site was very muddy (ankle deep in places) and the exposed parts of both trenches were covered in puddles. The sides of the southwestern end of Trench B had also collapsed. As the rain was continuing, it was decided to abandon digging of the day.

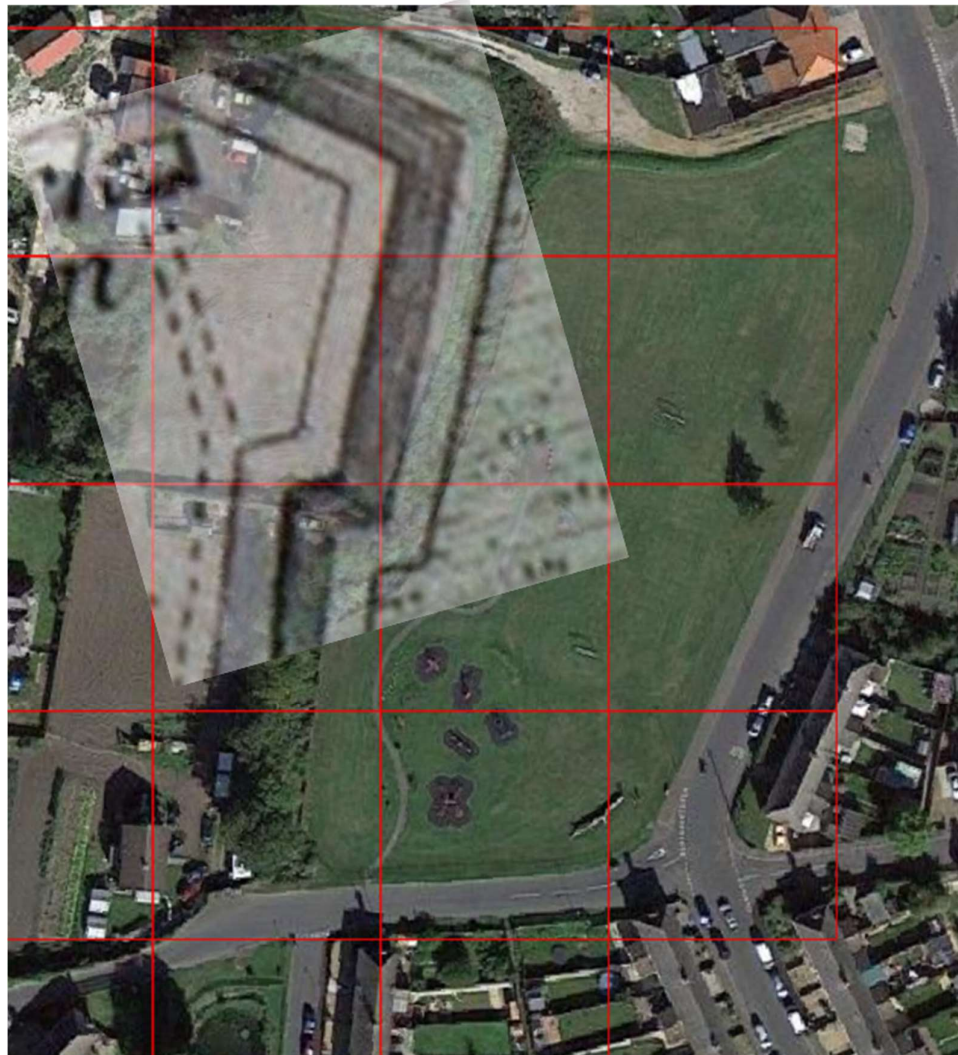
Figure 75 – The 1797 plan overlaid on a modern aerial photograph

According to the 1797 and 1812 plans, the North East bastion brick kiln was positioned against the inside of the north-west flank of the bastion, with a track running approximately south-eastwards across the base of the bastion. The 2021 investigation found (at the western end of the trench) a small quantity of mis-fired and blown bricks (likely to be caused by bricks being insufficiently dried out prior to

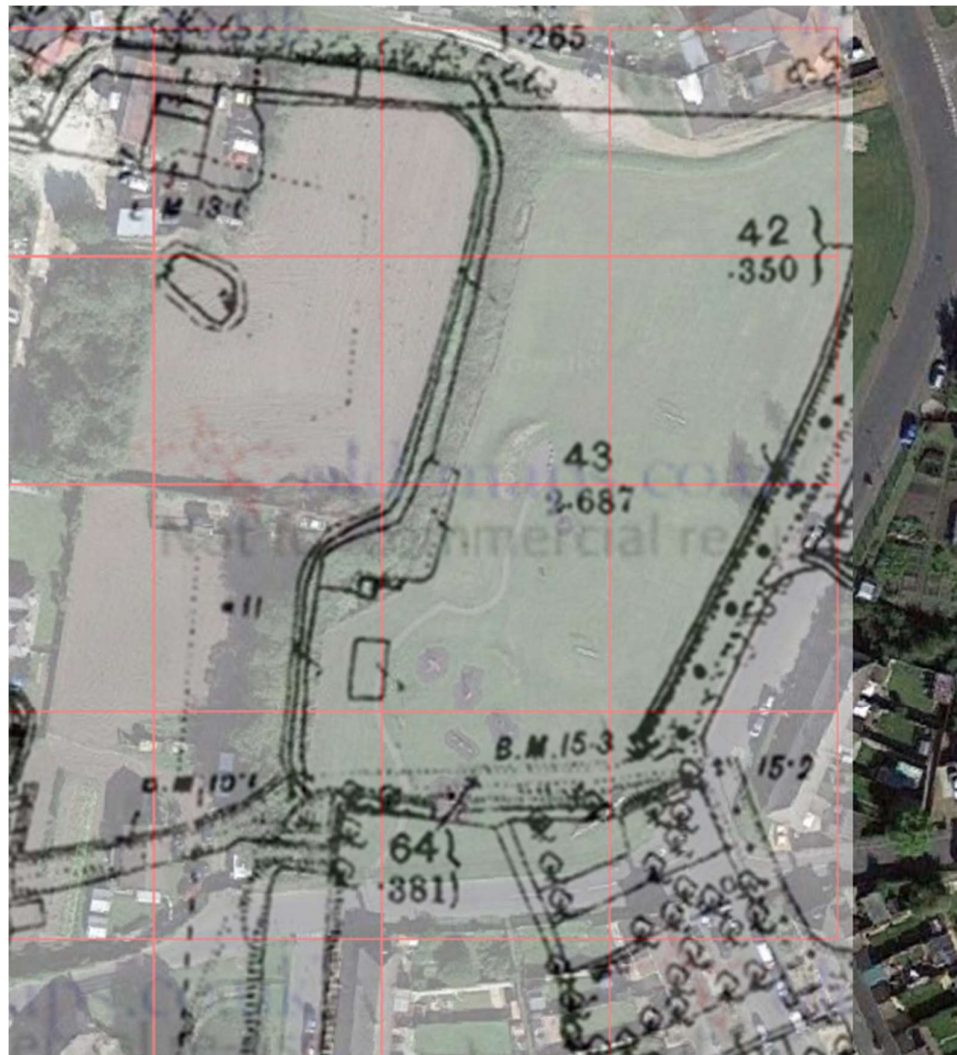
*Figure 76 – The 1887 Ordnance Survey map overlaid on a modern aerial photograph*

It is not known when brick making ceased. The kiln was shown on the Ordnance Survey 1 inch to 1 mile First Series Maps of the British Isles (1805-1845), but by the time of the 1886-7 Ordnance Survey, there were no surface traces of the rampart, whilst the moat had been narrowed to what would later be known as the "Drain", which enclosed an area of open land depicted on the 1887 Ordnance Survey map. This map shows two features: a small structure close to the inside of the northern face bastion (to the east of the western flank), and to the south of this feature, a small pond.

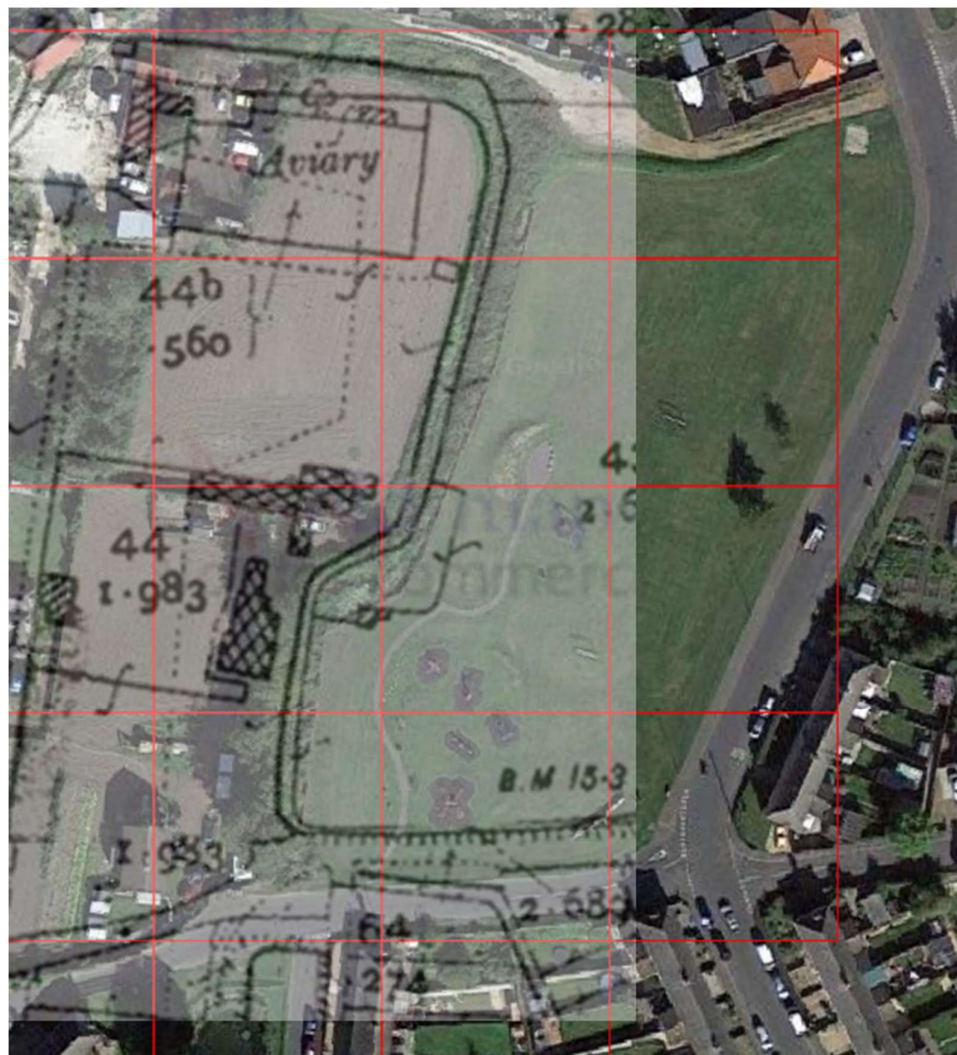
Between the Ordnance Survey of 1886-87 and the next one in 1905, the site witnessed significant development. The structure featured in 1886-7 had been extended with a new wing running southwards, whilst further to the east, against the inside face of the bastion, an aviary had been constructed. This period also marks the start of the site's transition into a market garden. The site is crisscrossed by a number of tracks and paths, whilst towards the southern edge of the site, several greenhouses have appeared – the 1905 survey shows three, all close by the southern flank of the bastion. A further building has been constructed by the track which runs south to north along almost the entire length of the bastion.

*Figure 77 – The 1905 Ordnance Survey map overlaid on a modern aerial photograph*

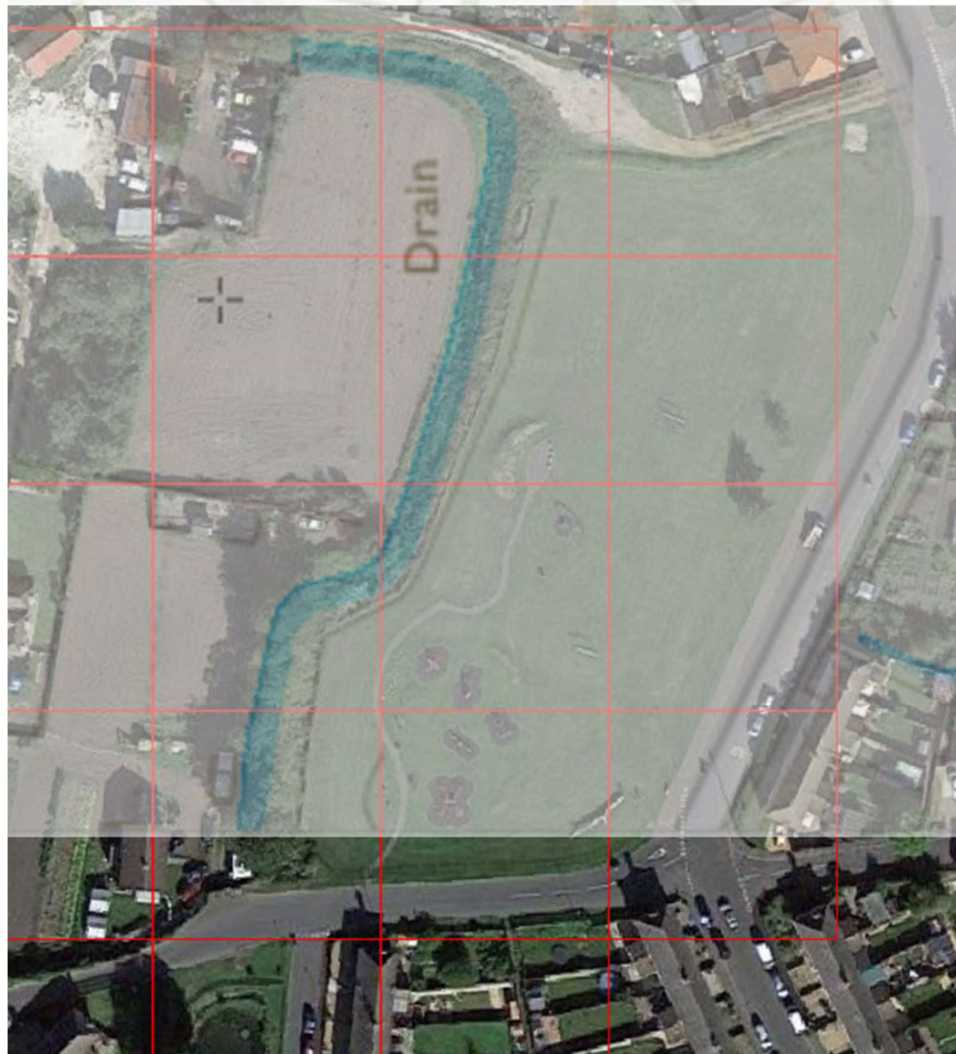
*Figure 79 – A modern Ordnance Survey map overlaid on a modern aerial photograph*

King's Lynn Under Siege first encountered the site of the North East bastion in January 2020. Until the summer of 2021, the site was viewed only externally from the neighbouring recreation ground which borders the entire length of the site's eastern edge. Outside the site to the north is an unmetalled track which provides vehicular access to the rear of the house on Turbus Road. The western edge of the site has been divided by corrugated metal fencing, behind which are other properties, reached via Rope Walk. Part of the northern face and the entire western flank of the bastion lies beneath this area and is not accessible. Along the southern

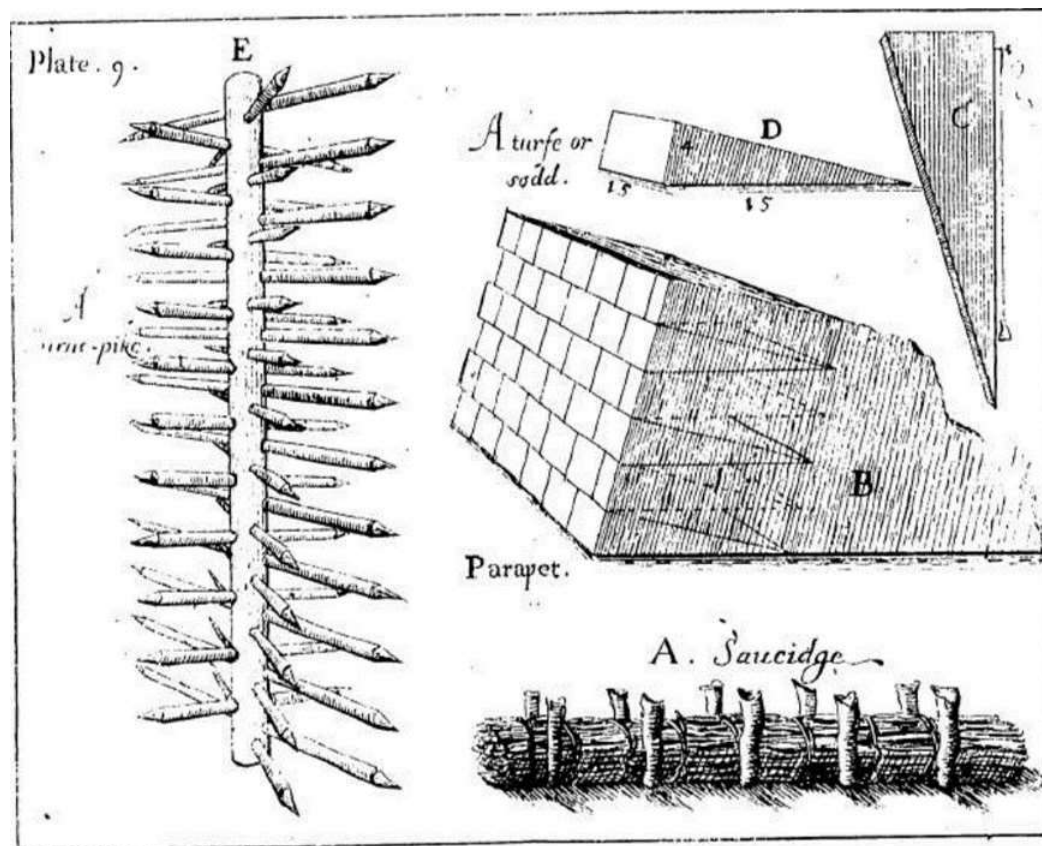
Figure 81 – Plate 9 of Nicholas Stone's *Enchiridion of Fortification* Or *A Handfull of Knowledge in Martiall Affaires* (1645) illustrating how turfs were to be cut, and then used to face ramparts. Also shown is the 'saucidge', something that may well have been used to construct a rampart

(‘sausage’) which was a wooden stake of between 30.48-60.96cm (one and two feet) in height, tied together with “brush wood”. Such foundations needed to be specifically secured near the ditch (moat)<sup>25</sup>. Stone’s account together with the archaeological evidence from 2021 and 2022 has allowed a likely method of rampart construction to be devised. This method is set out at Appendix 27.

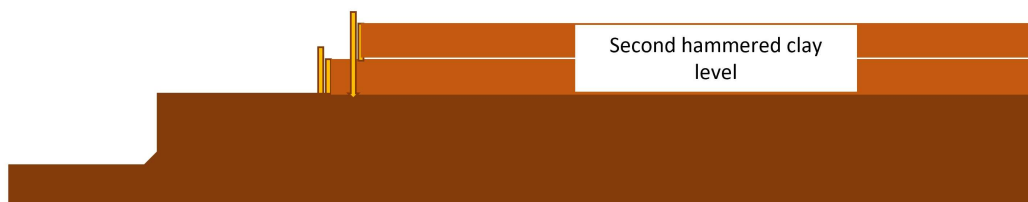
### Four

Line of posts inserted along next level. Planking (or brushwood bundle) lined against posts  
 Second clay level added (clay is hammered)
